GREENFUSION TECHNOLOGIES LIMITED

BRIEFING ON SITE ASSESSMENT AND MOTOR INSTALLATIONS FOR MERTI BH.

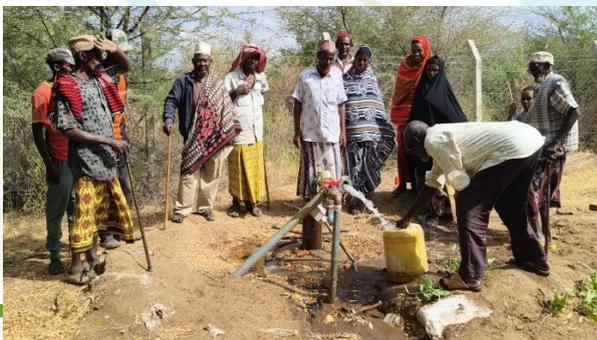
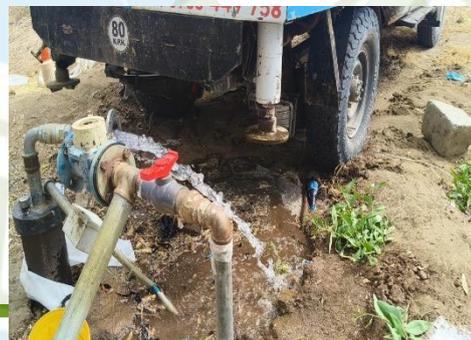
TESTING AND COMISIONING

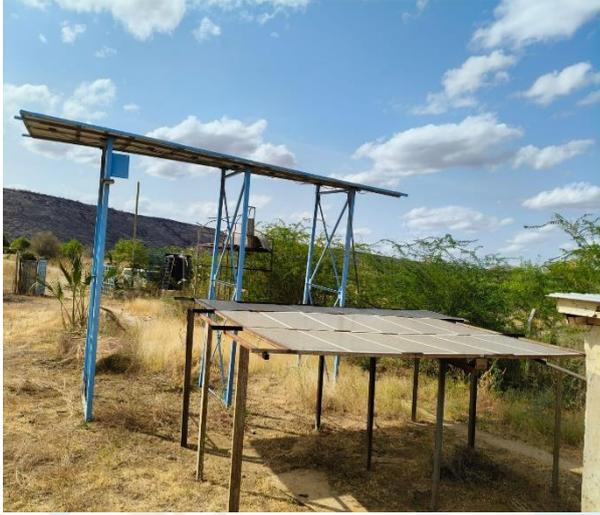
- ❖ The system has two solar structures with one taller than the other leading shading effect on the shorter structure, therefore negatively affects the operation mode of the system by reducing the voc, frequency hence low water discharge/pumped.
- ❖ Five Solar panels crashed hence reduce maximum light absorption for power generation.
- ❖ Convectional control panel for generator and changeover distorted hence by-passed to run the system efficiently.
- ❖ 2 pump impellers had crack.

SHADE ON THE PANELS (NEED TO BE ADRESSED)

- Demolition of the existing 2 solar structures and re-fabricate with the use of the same materials.
- Purchase the new panels to replace the damaged one.
- Introduce a separate control panel for the motor via genset via new changeover switch.
- Alternative pump which is easily affordable

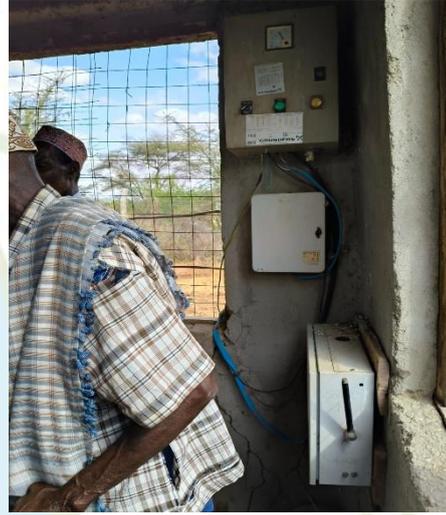
DISTOTED AND WORN CONTOL PANEL FOR GENSET

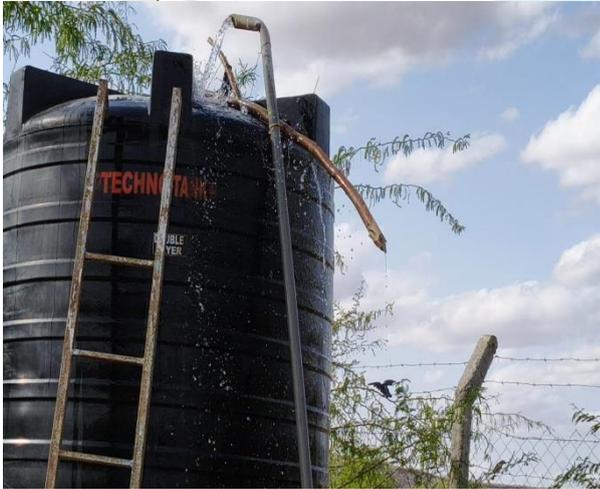
WATER FLOWING IN THE TANK
