## REPORT ON SERA SANCUARY WATER WORKS

01/12/2025 We attended to Lchosowang new well for motor replacements and 9-1 spectra desalination plant servicing and assessment for Lontopi B/ New well

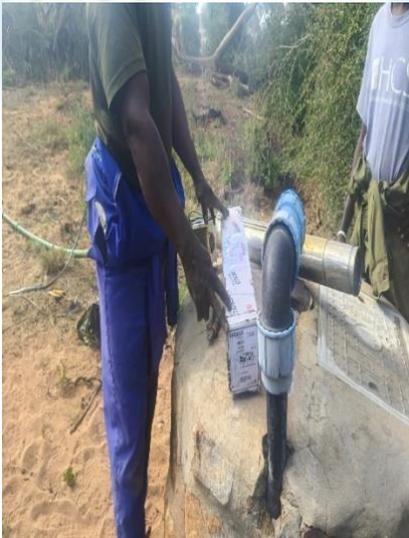
Boxed pedrollo motor

Purchase and supply of Pedrollo motor 1.1kw 1phase 1.5hp, 1.5mm dual landed cable 10m, ppr fitting and installation sundries for motor installation, programming of the control panels, tested ok and commissioned.

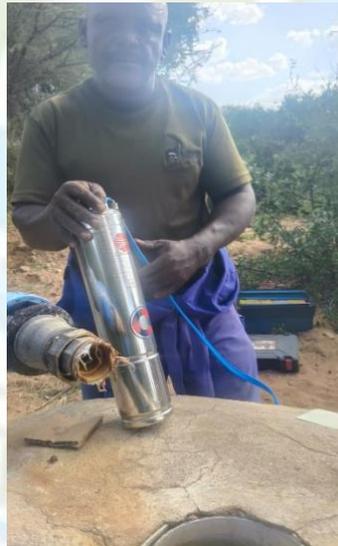
Unboxed pedrollo motor

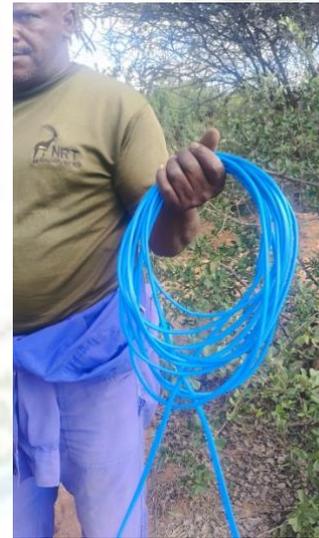
10 m Londex cable for sensor.

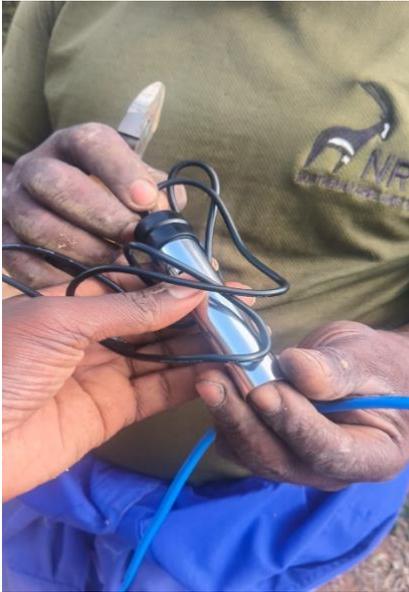
Well probe sensor

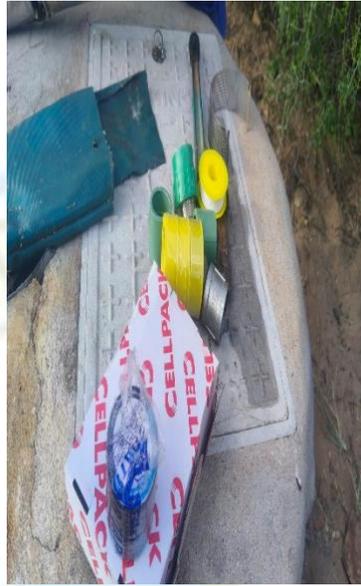
Slicing kit and installation sundries

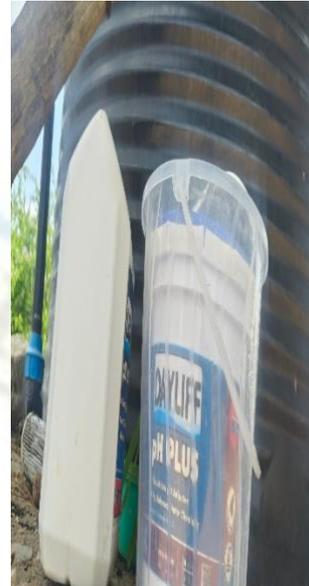
PH- AND PH + SOLUTIONS

Purchased and supplied pH- and pH+ solutions for servicing the machine. Unfortunately, the system 9-1 team continued to operate the unit despite our clear instruction to stop until servicing was completed, stating that they had no alternative due to operational needs. Continued operation in this condition resulted in damage to the piston chamber, which in turn exerted excess pressure on the membrane. We subsequently dismantled the system to assess the extent of the damage and confirmed that the membranes were also partially damaged.

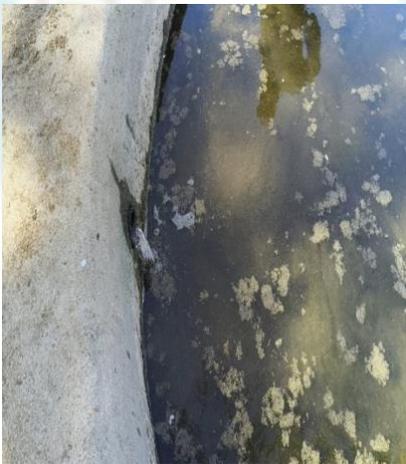
The well had sufficient water and there are sign of quick recharge rate due to the flowing water adjacent to the shallow well.

WATER FLOWING INTO THE PAN

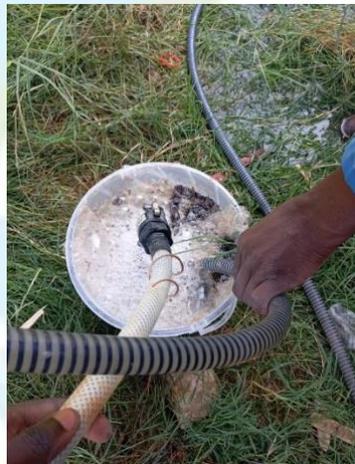
CLEANING OF THE  
DELINATION PLANT

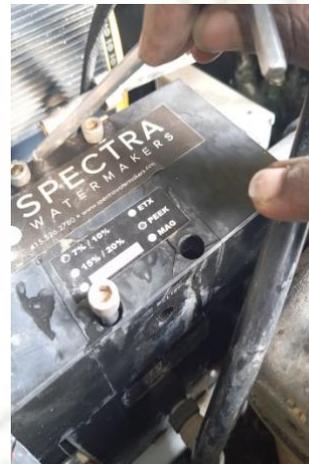
PHOTO FOR THE BOKEN  
PISTON.

- We can source spare parts from one of the damaged stored plants at Lewa store to repair the system.
- The plant to be repaired should serve the teams on temporary basis giving room for long term method.
